**DEPARTMENT OF TRANSPORTATION****DIVISION OF ENGINEERING SERVICES**

Contract #: 04-0120F4Cty: SF/ALA Rte: 80 PM: 13.2/13.9File #: 69.28**WELDING INSPECTION REPORT****Resident Engineer:**Pursell, Gary**Address:** 333 Burma Road**City:** Oakland, CA 94607**Report No:** WIR-001189**Date Inspected:** 20-Dec-2007**Project Name:** SAS Superstructure**OSM Arrival Time:** 630**Prime Contractor:** American Bridge/Fluor Enterprises, a JV**OSM Departure Time:** 1530**Contractor:** Zhenhua Port Machinery Company, Ltd (ZPMC), Changxing Island **Location:** Shanghai, China**CWI Name:** Shen Xue Jun**CWI Present:** Yes No**Inspected CWI report:** Yes No N/A**Rod Oven in Use:** Yes No N/A**Electrode to specification:** Yes No N/A**Weld Procedures Followed:** Yes No N/A**Qualified Welders:** Yes No N/A**Verified Joint Fit-up:** Yes No N/A**Approved Drawings:** Yes No N/A**Approved WPS:** Yes No N/A**Delayed / Cancelled:** Yes No N/A**Bridge No:** 34-0006**Component:** OBG and Tower Mock-up**Summary of Items Observed:**

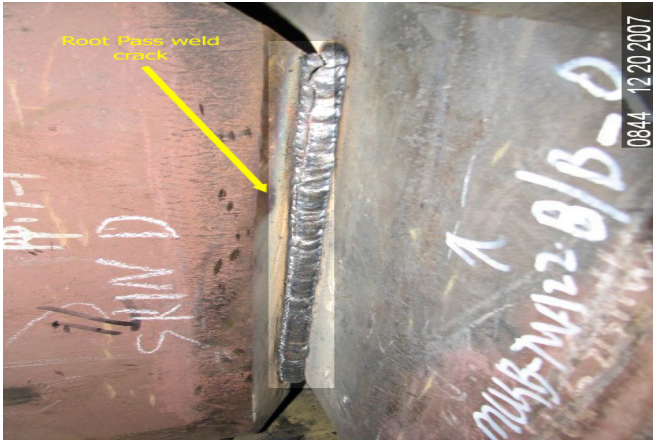
- 4 Root Pass Crack at the Skin D, MA-22 Subassembly Tower Mock-up 89 M  
ZPMC QC Shen Xue Jun informed to the QA inspector that the root pass for the weld joint # 8 at the Skin D, MA-22 subassembly cracked from start to end. See the photograph below. Mr. Xue Jun Xue said that ZPMC would removed the weld completed, perform magnetic particle inspection and rewelded again.

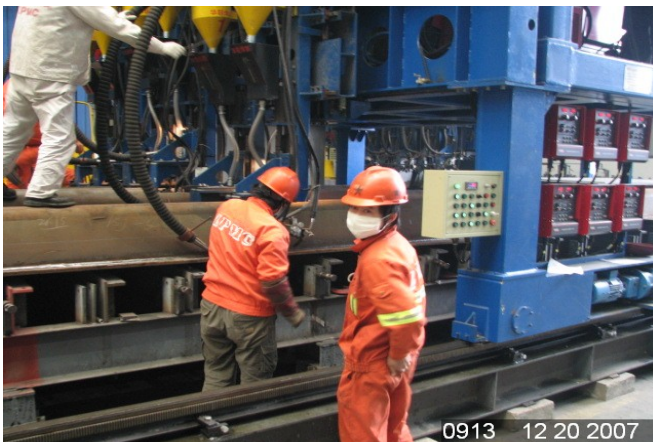
- 5 OBG Gantry U-ribs

The QA inspector observed that ZPMC was practicing with the second U-ribs gantry on this date. See photograph below.
